Drive modernization at a cement facility

SEW-EURODRIVE engineered a **10% more efficient solution** — saving a leading cement producer a lot more than just money.

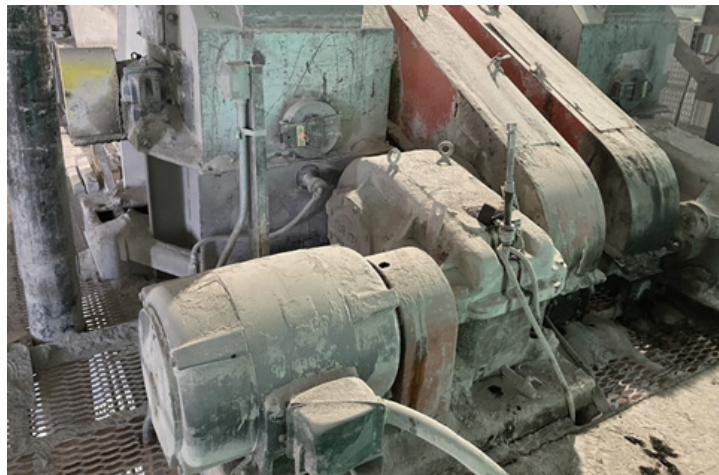
Before

Running an archaic chain-and-sprocket drive on four bucket elevators, a leading cement producer was struggling with inefficiency and downtime, costing thousands of dollars in lost production.

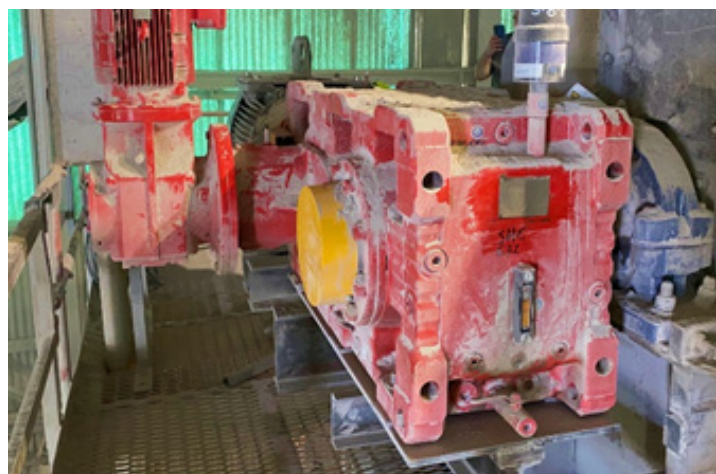
After

SEW-EURODRIVE replaced the dated chain-and-sprocket drive with a modern, direct-coupled gearbox and motor from our X.e Series units.

Additionally, SEW used severe-duty grade paint, a desiccant breather, and labyrinth-style grease-able seals to guard against cement dust and high temperatures.

- X3K large industrial gear unit for the main elevator drive; 125 HP motor with 323,800 lb-in of torque
- KF97 auxiliary gearmotor that turns output shaft at 1/10th the normal operating speed for easy maintenance

Replacing the cement plant's dated chain-and-sprocket drive with an SEW direct-coupled gearbox and motor system resulted in multiple efficiencies.

- Reduced the entire footprint, allowing for more space
- Eliminated the need for recurring chain lubrication, reducing time and costs
- Simplified the installation process, negating the manual alignment required for a foot-mounted motor
